### City of Carmel-by-the-Sea

Task 1 and 2: Coastal Engineering Assessment and Seasonal and Long-term Beach and Shoreline Change Analysis

**Climate Committee Meeting**

#### Coastal Engineering Assessment

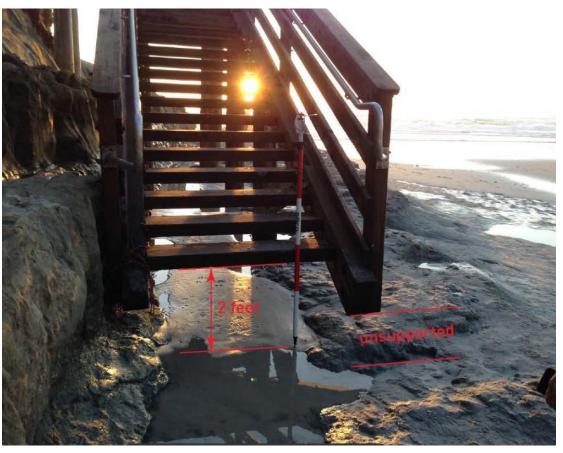
ST4 at 12<sup>th</sup> Ave. Source: Greg Easton, 2016

Right: The beach access stairway at Scenic Rd and 12<sup>th</sup> Ave has significantly corroded hardware and splitting wood members.

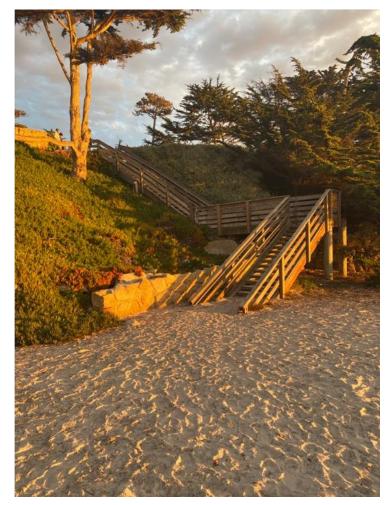
ST 8 between 9th Ave and 10th Ave

- Beach sand at high elevation along the backshore
- · Stairs function well

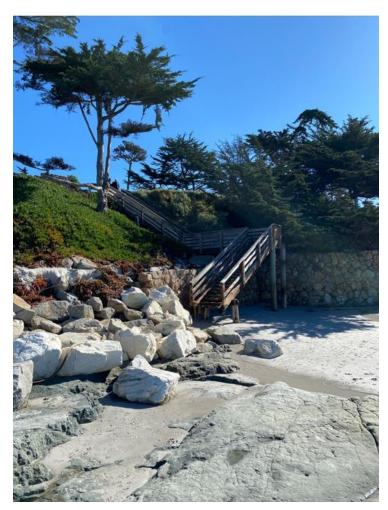
ST7 between 10th and 9th

- Deep sand scour condition along backshore
- Stairs have a several feet vertical drop
- Beachgoers may get stranded or jump
- Needs: additional treads+ landing to bedrock platform

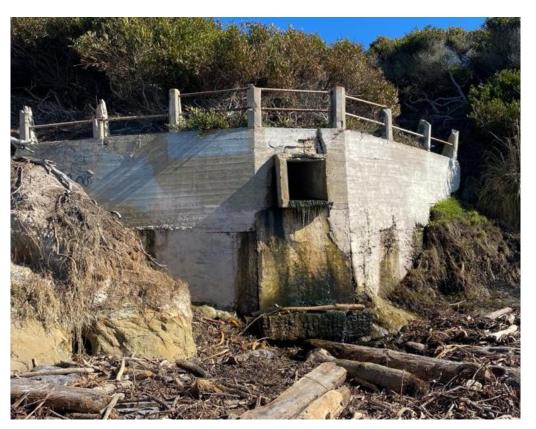
S10 between Carmel Way and Ocean Ave

- Seawall just west of the beach volleyball courts between Ocean Ave and Carmel Way.
- Structure is significantly deteriorated and is unstable.
- Demolish and rebuild.

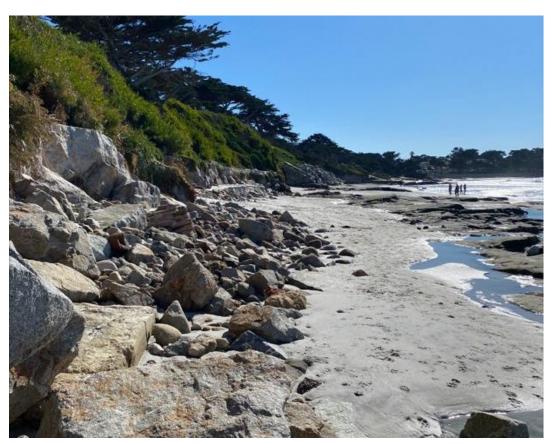
R4a between 10th Ave and 11th Ave

- Only **4** out of **6** rip rap revetments were inspected due to sand cover.
- 3 high priority ranking and 1 medium to very low.
- Issues:
  - Rip rap stacked at over steep slope gradient.
  - Undersized rip rap for wave forces.
  - Not properly keyed into bedrock.
- Remove undersize rock and rebuild

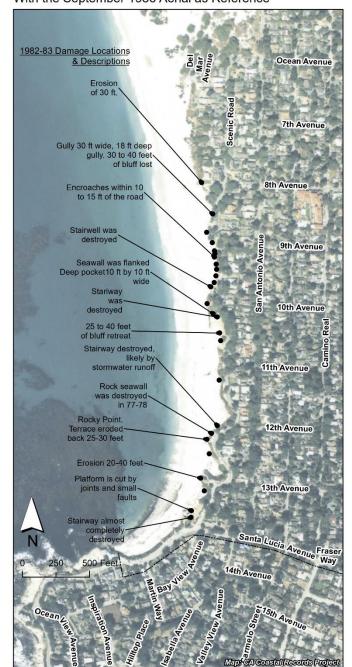
#### Winter 1982-83 El Niño Shoreline Damages With the September 1986 Aerial as Reference

- > Four stairways destroyed or partially destroyed
- > Significant outflanking of seawalls
- Significant bluff top erosion, in some places as much as 40 feet
- > City Public Works noted that the level of the back beach was 4-10 feet lower in the latter part of July than normal
